APPLICATIONS FOR A HAND-HELD, SUB-COATING IMAGING SYSTEM

LASER & PLASMA TECHNOLOGIES

APPLICATION NOTE APRIL 2015

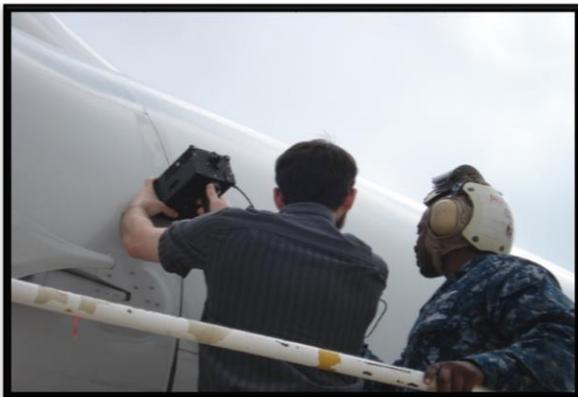
Figure 1. LPT-S2 in use at NAVAIR Jacksonville.

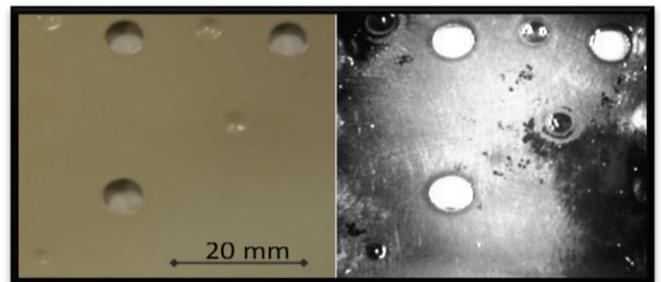
Figure 2. LPT-S2 imaging through coatings. *LEFT*: sample with P8 Poseidon primer + topcoat, no corrosion apparent. *RIGHT*: Sample as-imaged through LPT-S2, with dark areas indicating prevalent surface corrosion.

The LPT-S2 can be described as a handheld video imaging instrument *engineered to penetrate coating systems*. In order to resolve an image of the sub-coating surface, photons have to travel through the paint layers and reach the surface of the metal or composite. These photons must then return back through the paint to transmit surface information to a detector. The LPT-S2 is designed to generate and detect photons at wavelength bands transparent to many MIL-SPEC paint systems. Figure 2 shows one such example, with the instrument imaging through the standard paint scheme of a P8 Poseidon aircraft.

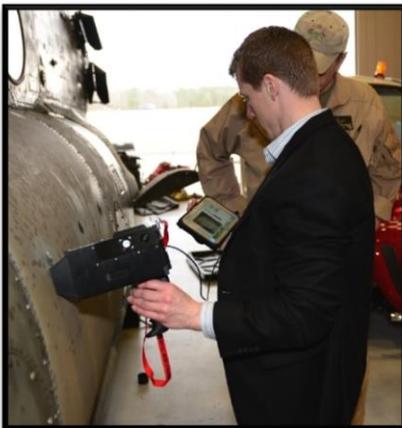
Figure 4. LPT-S2 system in use, with main instrument housing and tablet PC display shown.

Defects and corrosion tend to be more prevalent in constrained areas where moisture can collect, and at joining regions such as adhesive lips and rivets. With this in mind, a key criteria for LPT-S2 has been to design towards a miniaturized form factor with rugged construction. Battery power operation is essential to inspect assets without a tethered power supply cord.

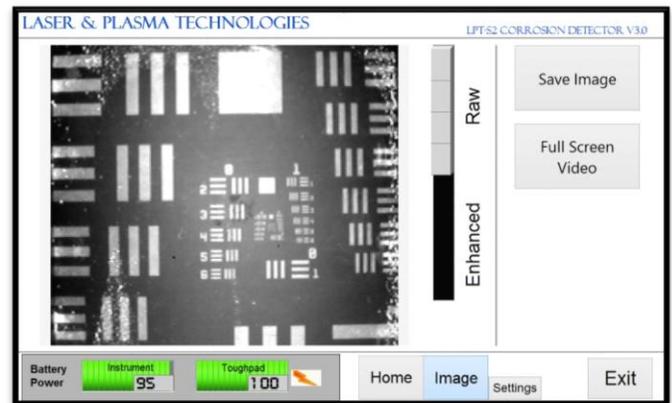
Figure 5. LPT-S2's custom software interface, showing an Air Force 1951 target resolved through a primer + topcoat paint system.

Instrument imaging (vs unaided eye inspection) also affords the ability to track trouble areas over time. LPT-S2 is driven by a powerful PC-based software program that provides image enhancement, data-basing, and customized metadata options.

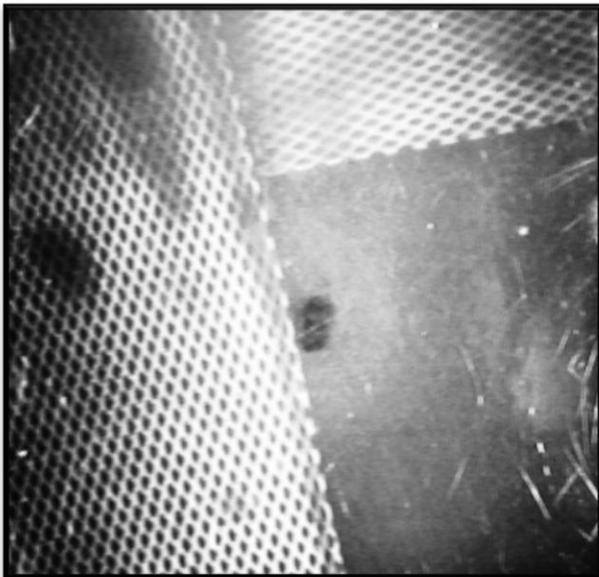
Figure 7. Conductive lightning arrestor mesh imaged through primer + topcoat coating system.
